CEDD CONTRACT AGREEMENT NO. EDO/04/2018 - ENVIRONMENTAL TEAM FOR CROSS BAY LINK, TSEUNG KWAN O

QUARTERLY ENVIRONMENTAL MONITORING AND AUDIT (EM&A) SUMMARY REPORT

(DECEMBER 2022 TO FEBRUARY 2023)

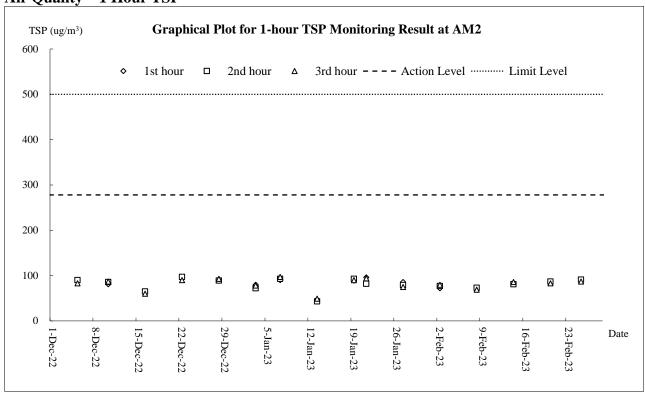
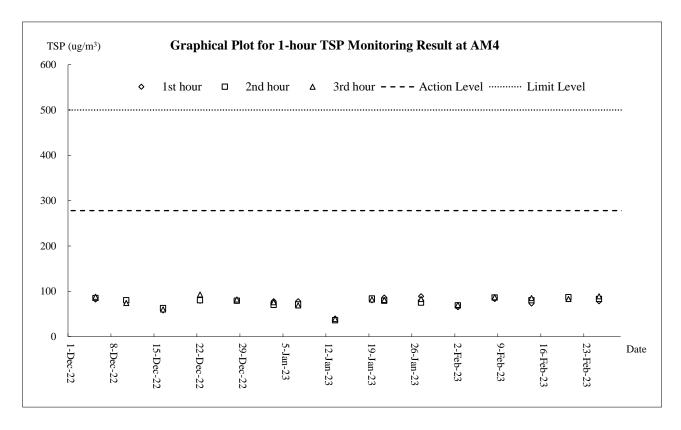
Air Quality - 1 Hour TSP

- 4.1.4 As shown in *Table 4-1*, all the 1-hour TSP and 24-hour TSP monitoring results were below the Action / Limit Levels. No Notification of Exceedance (NOE) was issued in this Reporting Period.
- 4.1.5 No adverse impact due to weather condition on the monitoring result was observed in reporting quarter. The summary of meteorological information for the Reporting Period is shown in *Appendix F*.
